Avian Mortality at Solar Energy Facilities in Southern California: A Preliminary Analysis

Rebecca A. Kagan, Tabitha C. Viner, Pepper W. Trail, and Edgard O. Espinoza
National Fish and Wildlife Forensics Laboratory

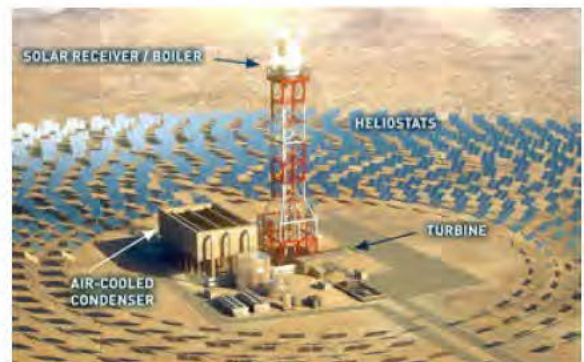
3) **Solar power towers** use thousands of mirrors to reflect the solar energy to a tower, where water in a boiler is converted to steam, generating the electricity. The perceived threat to birds is associated traumatic impact with the mirrors and the danger associated with the heat produced by the mirrors. An example of this type of solar power plant is Ivanpah Solar Electric Generating System.

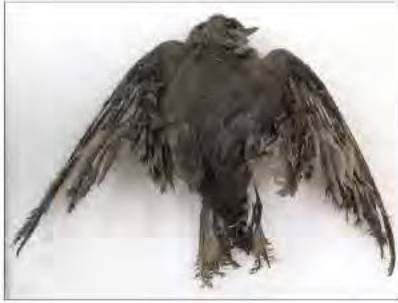
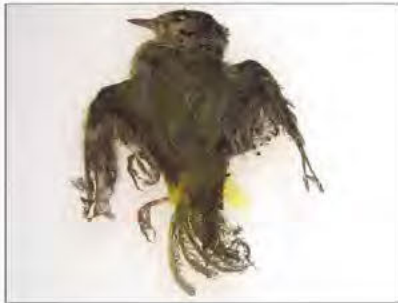
Birds with feather burns were graded based on the extent of the lesions. Grade 1 birds had curling of less than 50% of the flight feathers. Grade 2 birds had curling of 50% or more of the flight feathers. Grade 3 birds had curling and visible charring of contour feathers (Figure 1).

Figure 1: Three grades of flux injury based on extent and severity of burning. Grade 1 (top); Yellow-rumped Warbler with less than 50% of the flight feathers affected (note sparing of the yellow rump feathers). Grade 2 (middle); Northern Rough-winged Swallow initially found alive but unable to fly, with greater than 50% of the flight feathers affected. Grade 3 (bottom); MacGillivray's Warbler with charring of feathers around the head, neck, wings and tail.

Eight birds were assigned a feather damage Grade of 1 with curling of less than 50% of the flight feathers. Six of these had other evidence of acute trauma (75%). Five birds were Grade 2, including three birds that were found alive and died shortly afterwards. Of these birds, 2 (the birds found dead) also had evidence of acute trauma. Twenty-eight birds were Grade 3; with charring of body feathers. Of these birds, 21/28

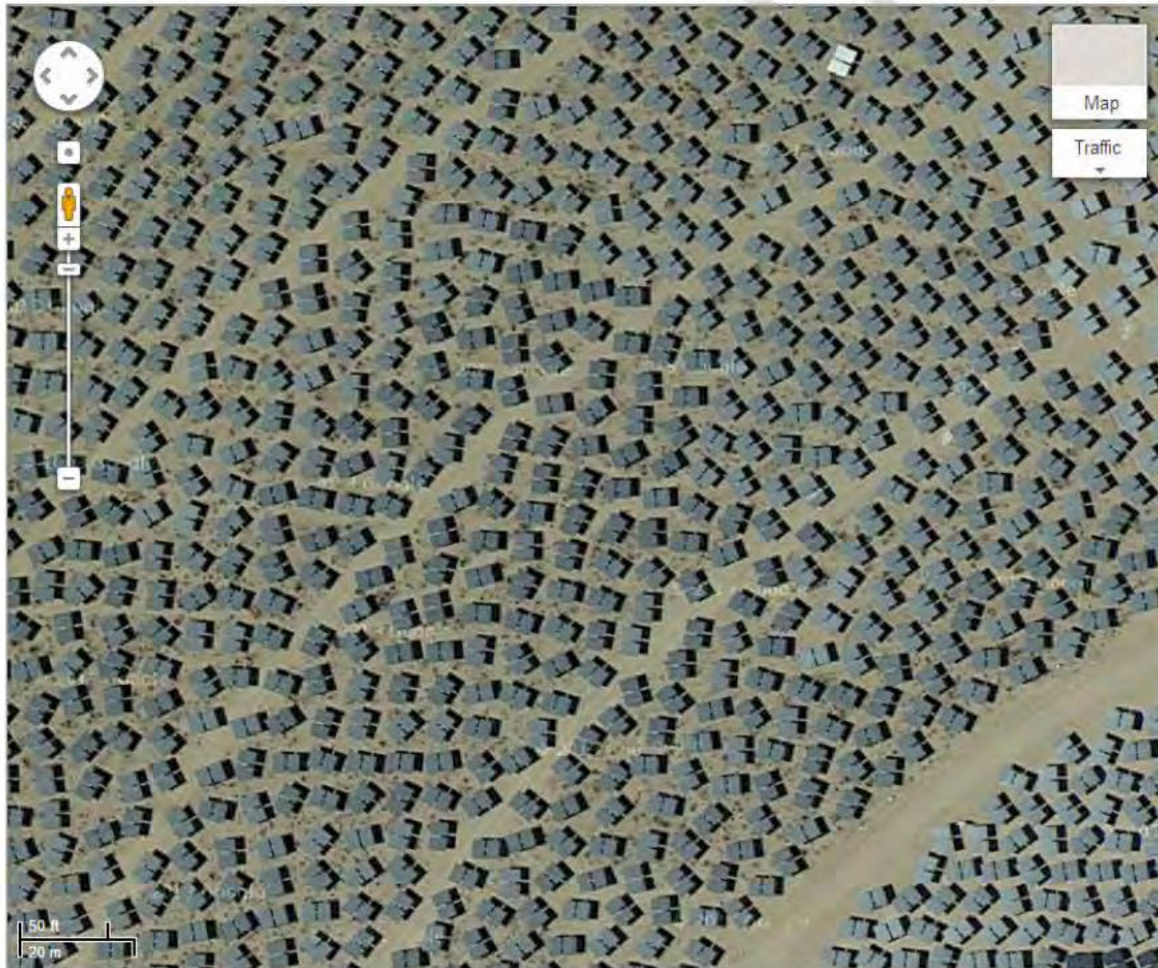
A desert environment punctuated by a large expanse of reflective, blue panels may be reminiscent of a large body of water. Birds for which the primary habitat is water, including coots, grebes, and cormorants, were over-represented in mortalities at the Desert Sunlight facility (44%) compared to Genesis (19%) and Ivanpah (10%). Several factors may inform these observations. First, the size and continuity of the panels differs between facilities. Mirrors at Ivanpah are individual, 4 x 8' panels that appear from above as stippling in a desert background (Figure 6). Photovoltaic panels at Desert Sunlight are long banks of adjacent 27.72 x 47.25" panels (70 x 120 cm), providing a more continuous, sky/water appearance. Similarly, troughs at Genesis are banks of 5 x 5.5' panels that are up to 49-65 meters long.

Figure 6: The Ivanpah Solar Electric Generating System as seen via satellite. The mirrored panels are 5 x 8 feet.

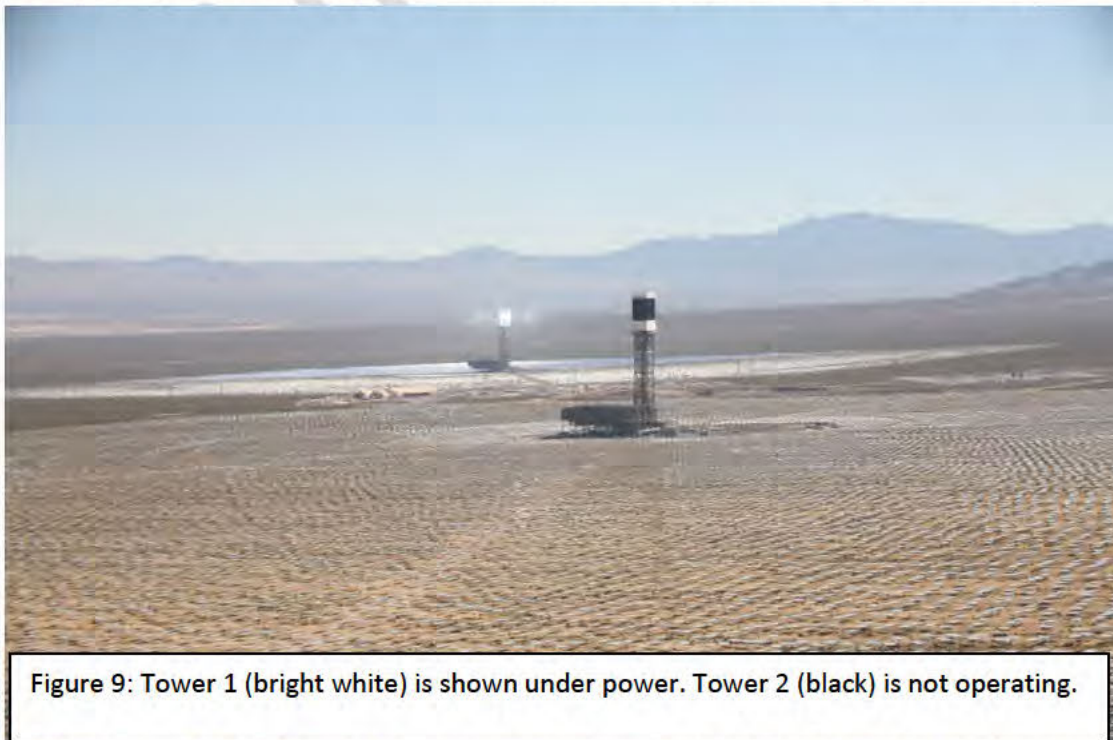
There is a phenomenon that occurs when the heliostats are focused on the tower and electricity is being generated. The phenomenon can be described as either a circle of clouds around the tower or, at times, a cloud formed on the side that is receiving the solar reflection. It appears as though the tower is creating clouds. Currently we propose two hypotheses of why this “cloud” is formed. The first hypothesis is simply the presumption that the high heat associated with towers is condensing the air, and forming the

Figure 9: Tower 1 (bright white) is shown under power. Tower 2 (black) is not operating.

clouds. The second hypothesis is that this phenomenon does not represent clouds at all rather it is a place in space where the heliostats that are not being used to generate heat are focused. Under this scenario, it is a place where the mirrors focus the excess energy not being used to generate electricity.

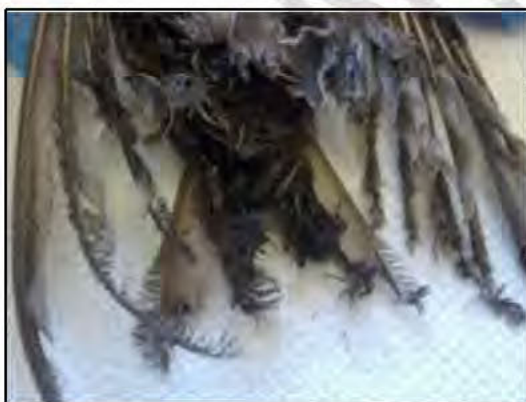
Many of the carcasses recovered from the Ivanpah Solar plant after the plant became operational showed singeing of feathers as shown in Figure 10.

Figure 10: Singed feathers from a Northern Rough-winged Swallow

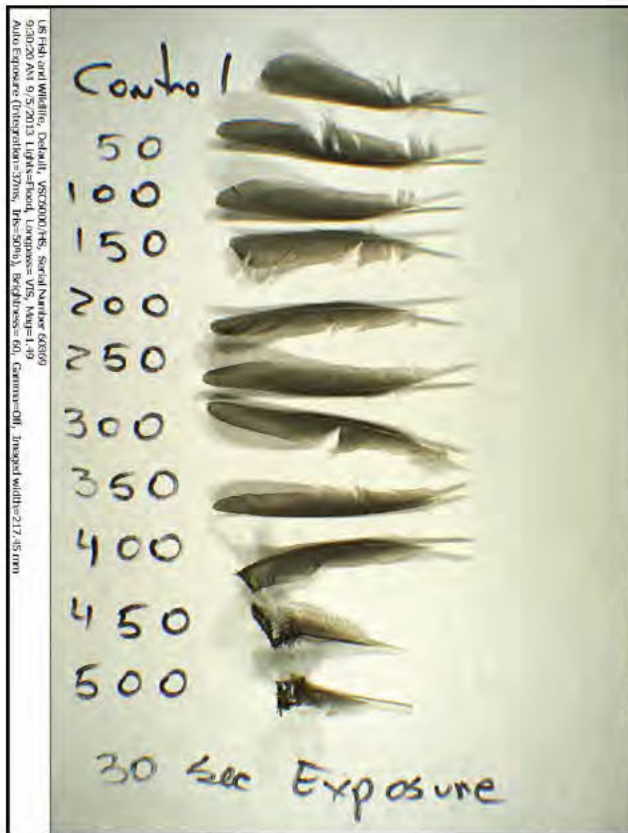
In order to investigate at what temperature feathers burn/singe, we exposed feathers to different air temperatures. Each feather was exposed to a stream of helium and air for 30 seconds. The results indicate that at 400° Celsius (752° Fahrenheit) after 30 seconds the feather begins to degrade. But at 450° and

Figure 11: Results of exposing feathers to different temperatures (in degrees Celsius)

500° Celsius (842° and 932° Fahrenheit respectively) the feathers singed as soon as they made contact with the superheated air (Figure 11). Therefore, when singed birds are found, it can be inferred that the temperatures in the solar flux at the time a bird flew through it was at least 400° Celsius (752° Fahrenheit). This inference is consistent with the desired operating temperature of a power tower solar boiler (482° Celsius).
